MVD Internal Review

28-Jan-2001

Technical status of MVD hardware

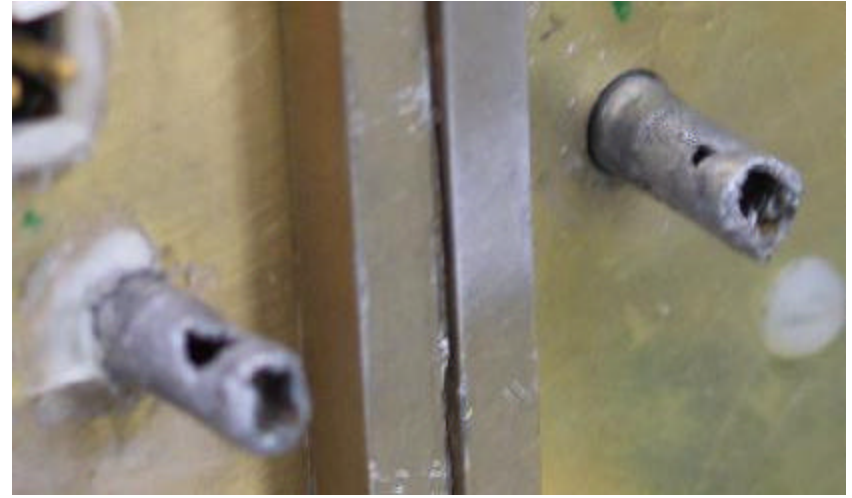
“Galvanic corrosion” where the brass fittings touched the Al tubes. Holes created when disconnecting the fittings.

The solution: Disassemble MVD, remove Al tubes, glue on Cu tubes. It is not conceptually hard. It will take ~2 person weeks to do this. In 1/1 previous tests, the tube came off the motherboard without problems.

Summary: We must fix this, but we know how.

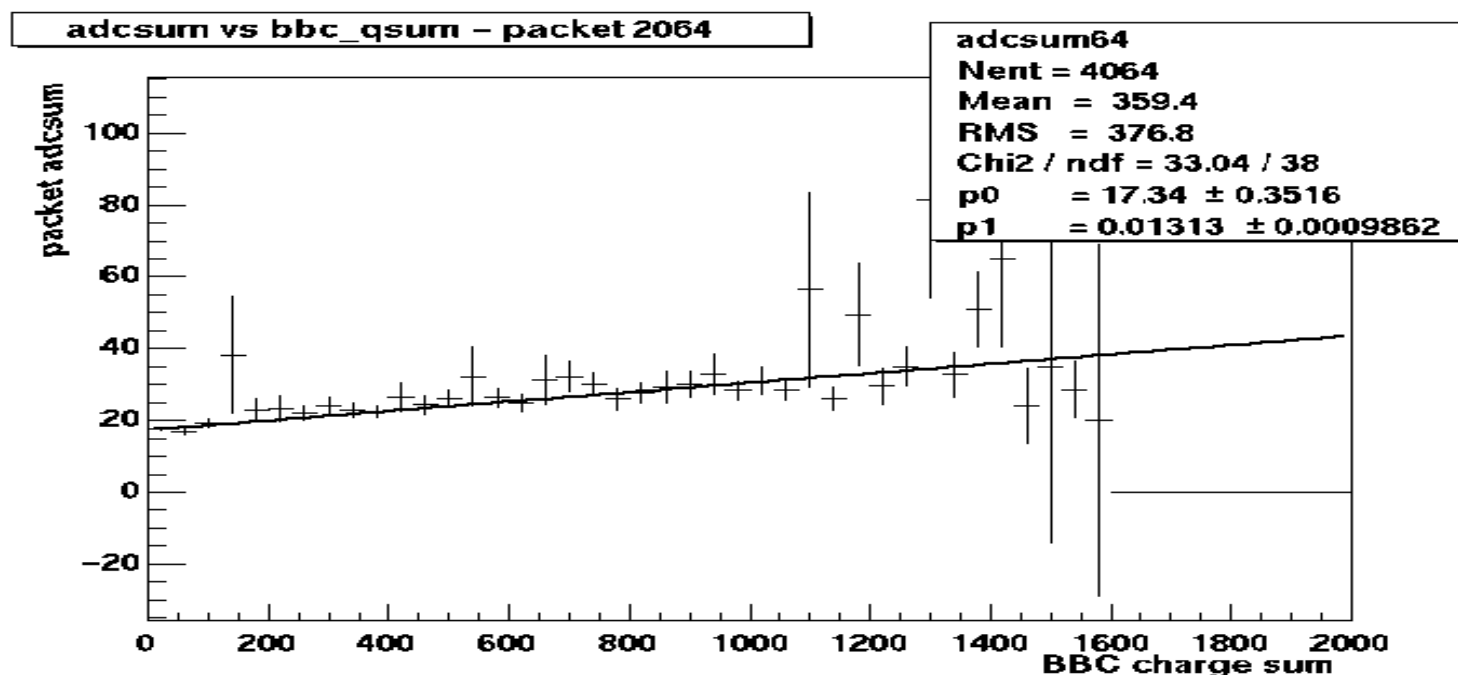
The problem does not seem to be no bias to the MCMs with poor signal/noise. One detector will not hold the bias voltage. For this detector, the slope of the MCM ADC sum vs. BBC ADC sum is ~ 20 lower than an MCM with “poor signal/noise”:

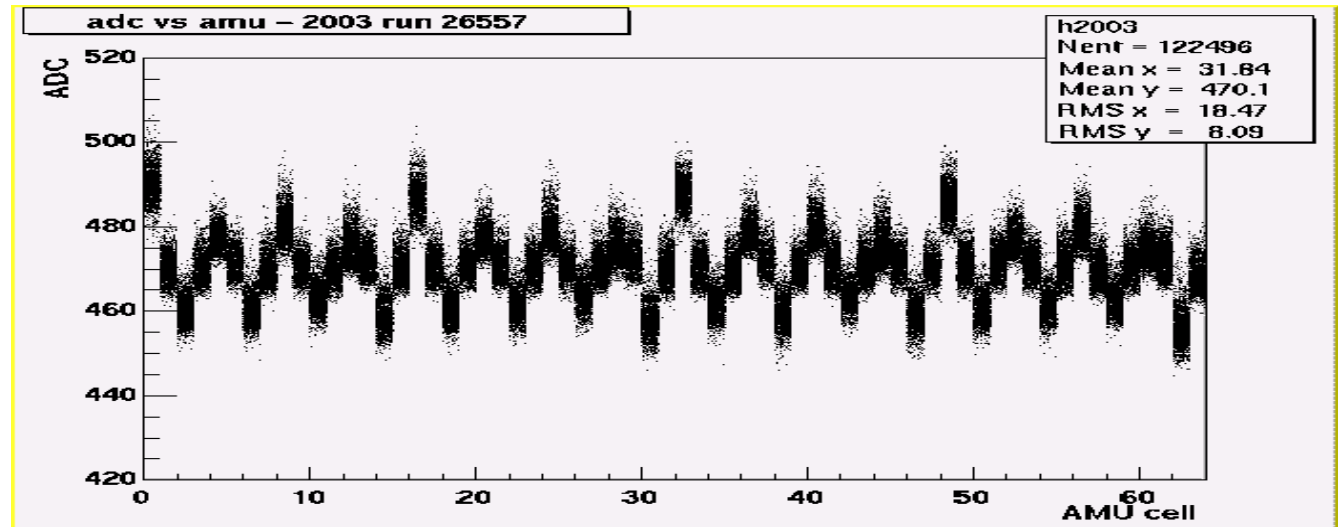
Pedestals depend
on AMU cell #

Both are problems for zero suppression.

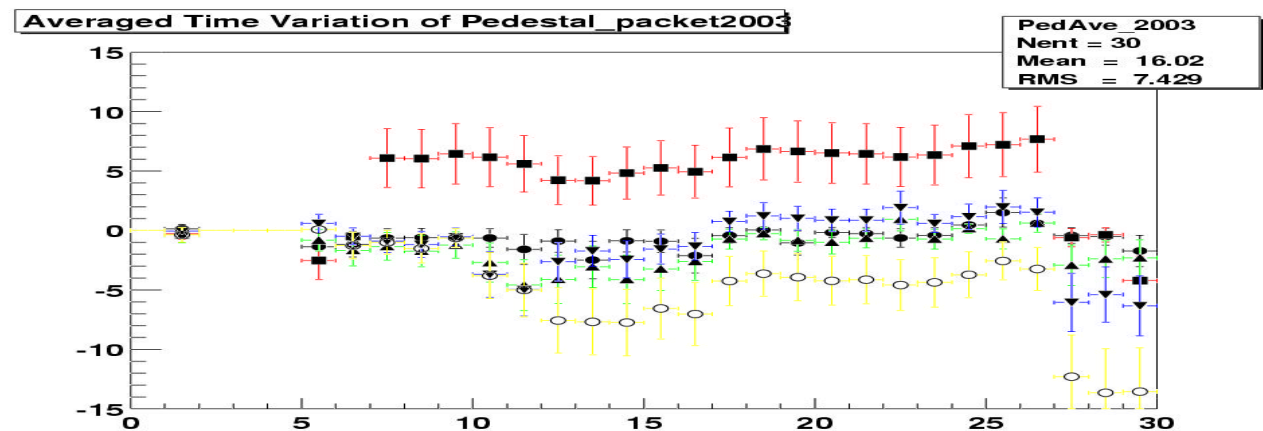
Pedestals drift:
(horizontal axis
represents runs
taken over ~10
days)

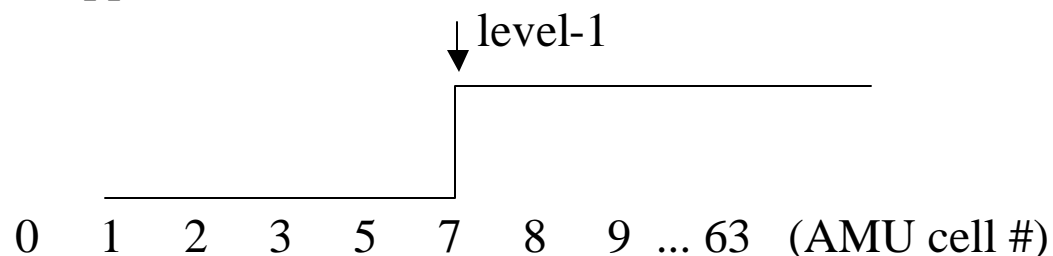
post - pre = 2 for first event, but cells 4 and 6 are removed from the list for ~35 us while this event is processed. In the meanwhile, the remaining 62 cells are used, so if there is a new event something like this could happen:

For this event, pre - post = 8-5 = 3, the DCM's lookup table for AMU cell dependent pedestal corrections will not work.

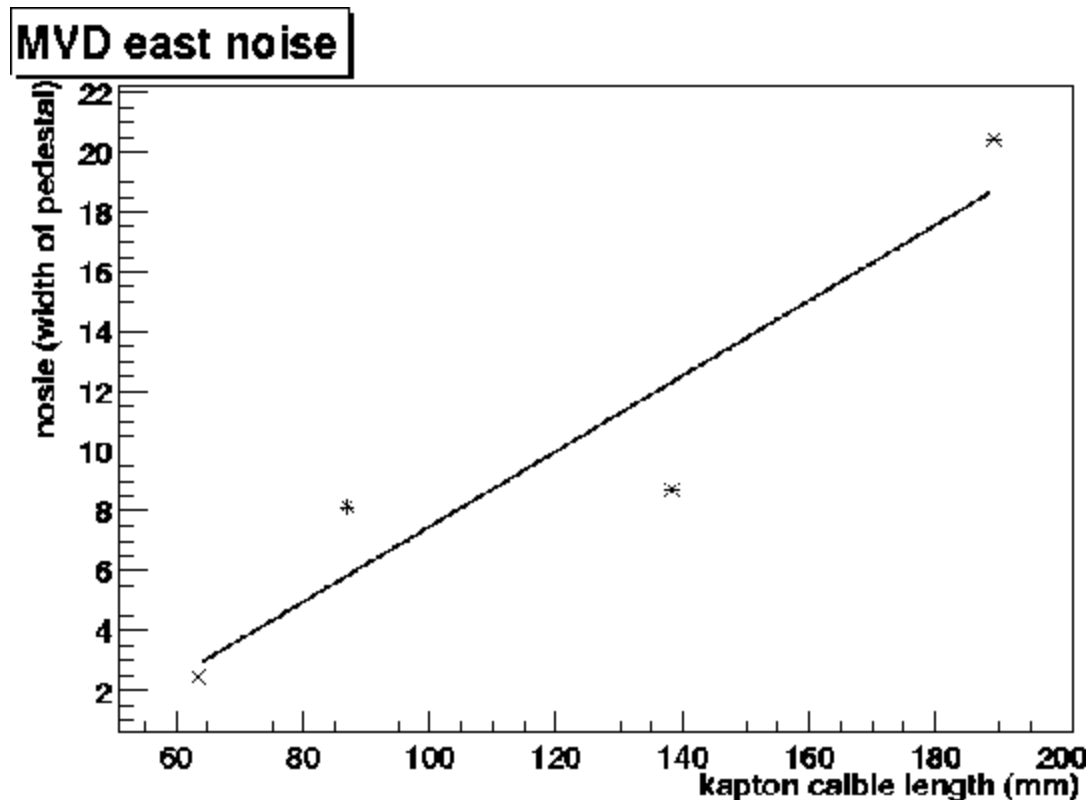
The pedestal width depends on the length of the cable connecting the Silicon detector and the MCM:

Add shielding around cables from detector to MCM -- should help with pedestal width at least.

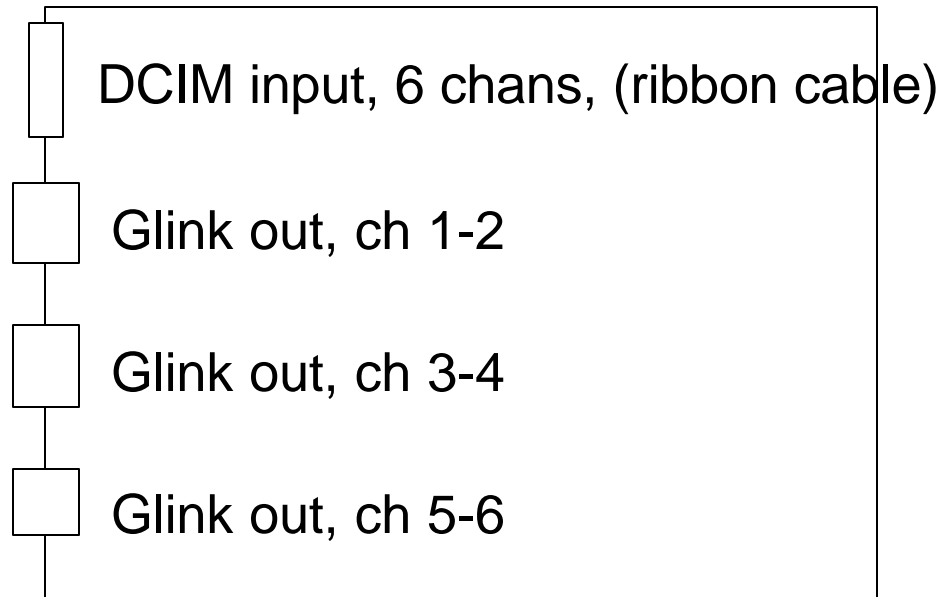
Sketch of a DCIM board

In the MVD barrel, channels 1-2 correspond to the ends. In the recent run, the ends of the barrel were not populated. Therefore, we could ignore the fact that channels 1-2 did not work on most DCIM boards.

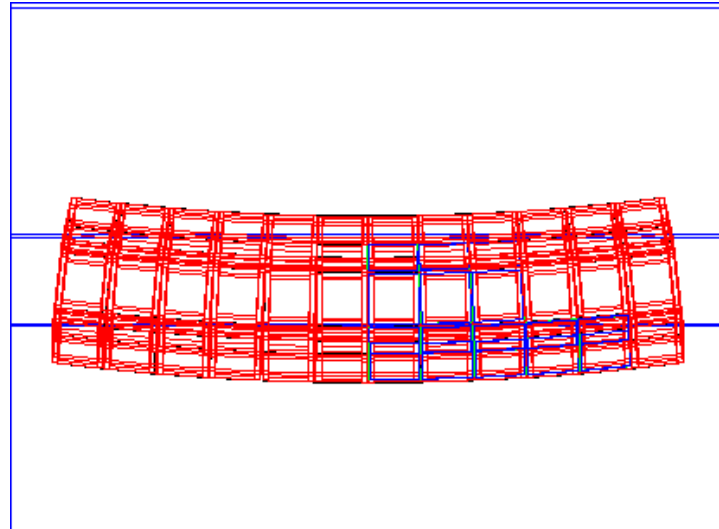
Side view: MVD sags down in the middle ~ 5mm (exaggerated in this sketch). We would like to reduce this.

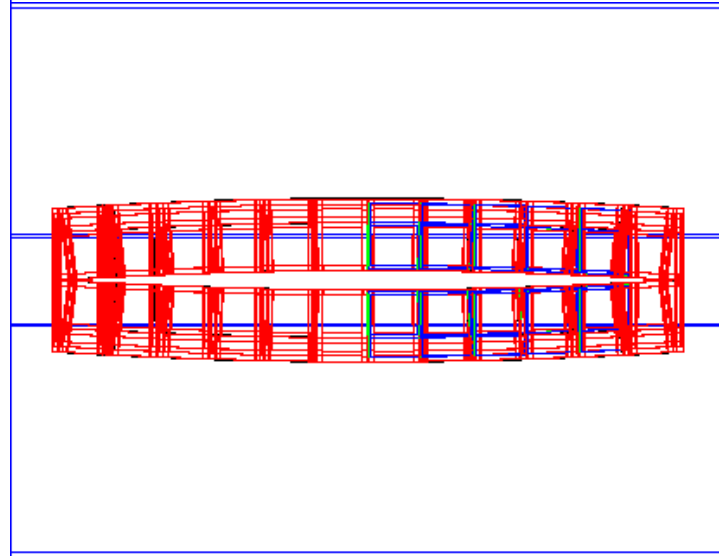
Top view: MVD bows out in the middle too (also exaggerated in sketch). We would like to reduce this too.
